DEER LODGE COUNTY	FRENCH CREEK RESTORATION IN FRENCH GULCH	PROJECT NUMBER 5002.004
	MONTANA	SHEET NUMBER ---
HABITAT IMPROVEMENT AREA 2		DRAWING NUMBER C-11

VERIFY SCALE! THESE PRINTS MAY BE REDUCED. LINE BELOW MEASURES ONE INCH ON ORIGINAL DRAWING. <div></div> MODIFY SCALE ACCORDINGLY!	REVISIONS				  MORRISON MAIERLE, INC. <i>An Employee-Owned Company</i>	3011 Palmer St. Missoula, MT 59808 Phone: (406) 542-8880 Fax: (406) 542-4801	Engineers Surveyors Scientists Planners	DRAWN BY: CRH DSGN. BY: MDB APPR. BY: RJA DATE: *** Q.C. REVIEW BY: *** DATE: ***	FRENCH CREEK RESTORATION IN FRENCH GULCH		PROJECT NUMBER 5002.004
	NO.	DESCRIPTION	DATE	BY					DEER LODGE COUNTY	MONTANA	SHEET NUMBER ---
									RESTORATION AREA 1 STA 0+00 TO 11+00 EARTHWORK		DRAWING NUMBER C-12

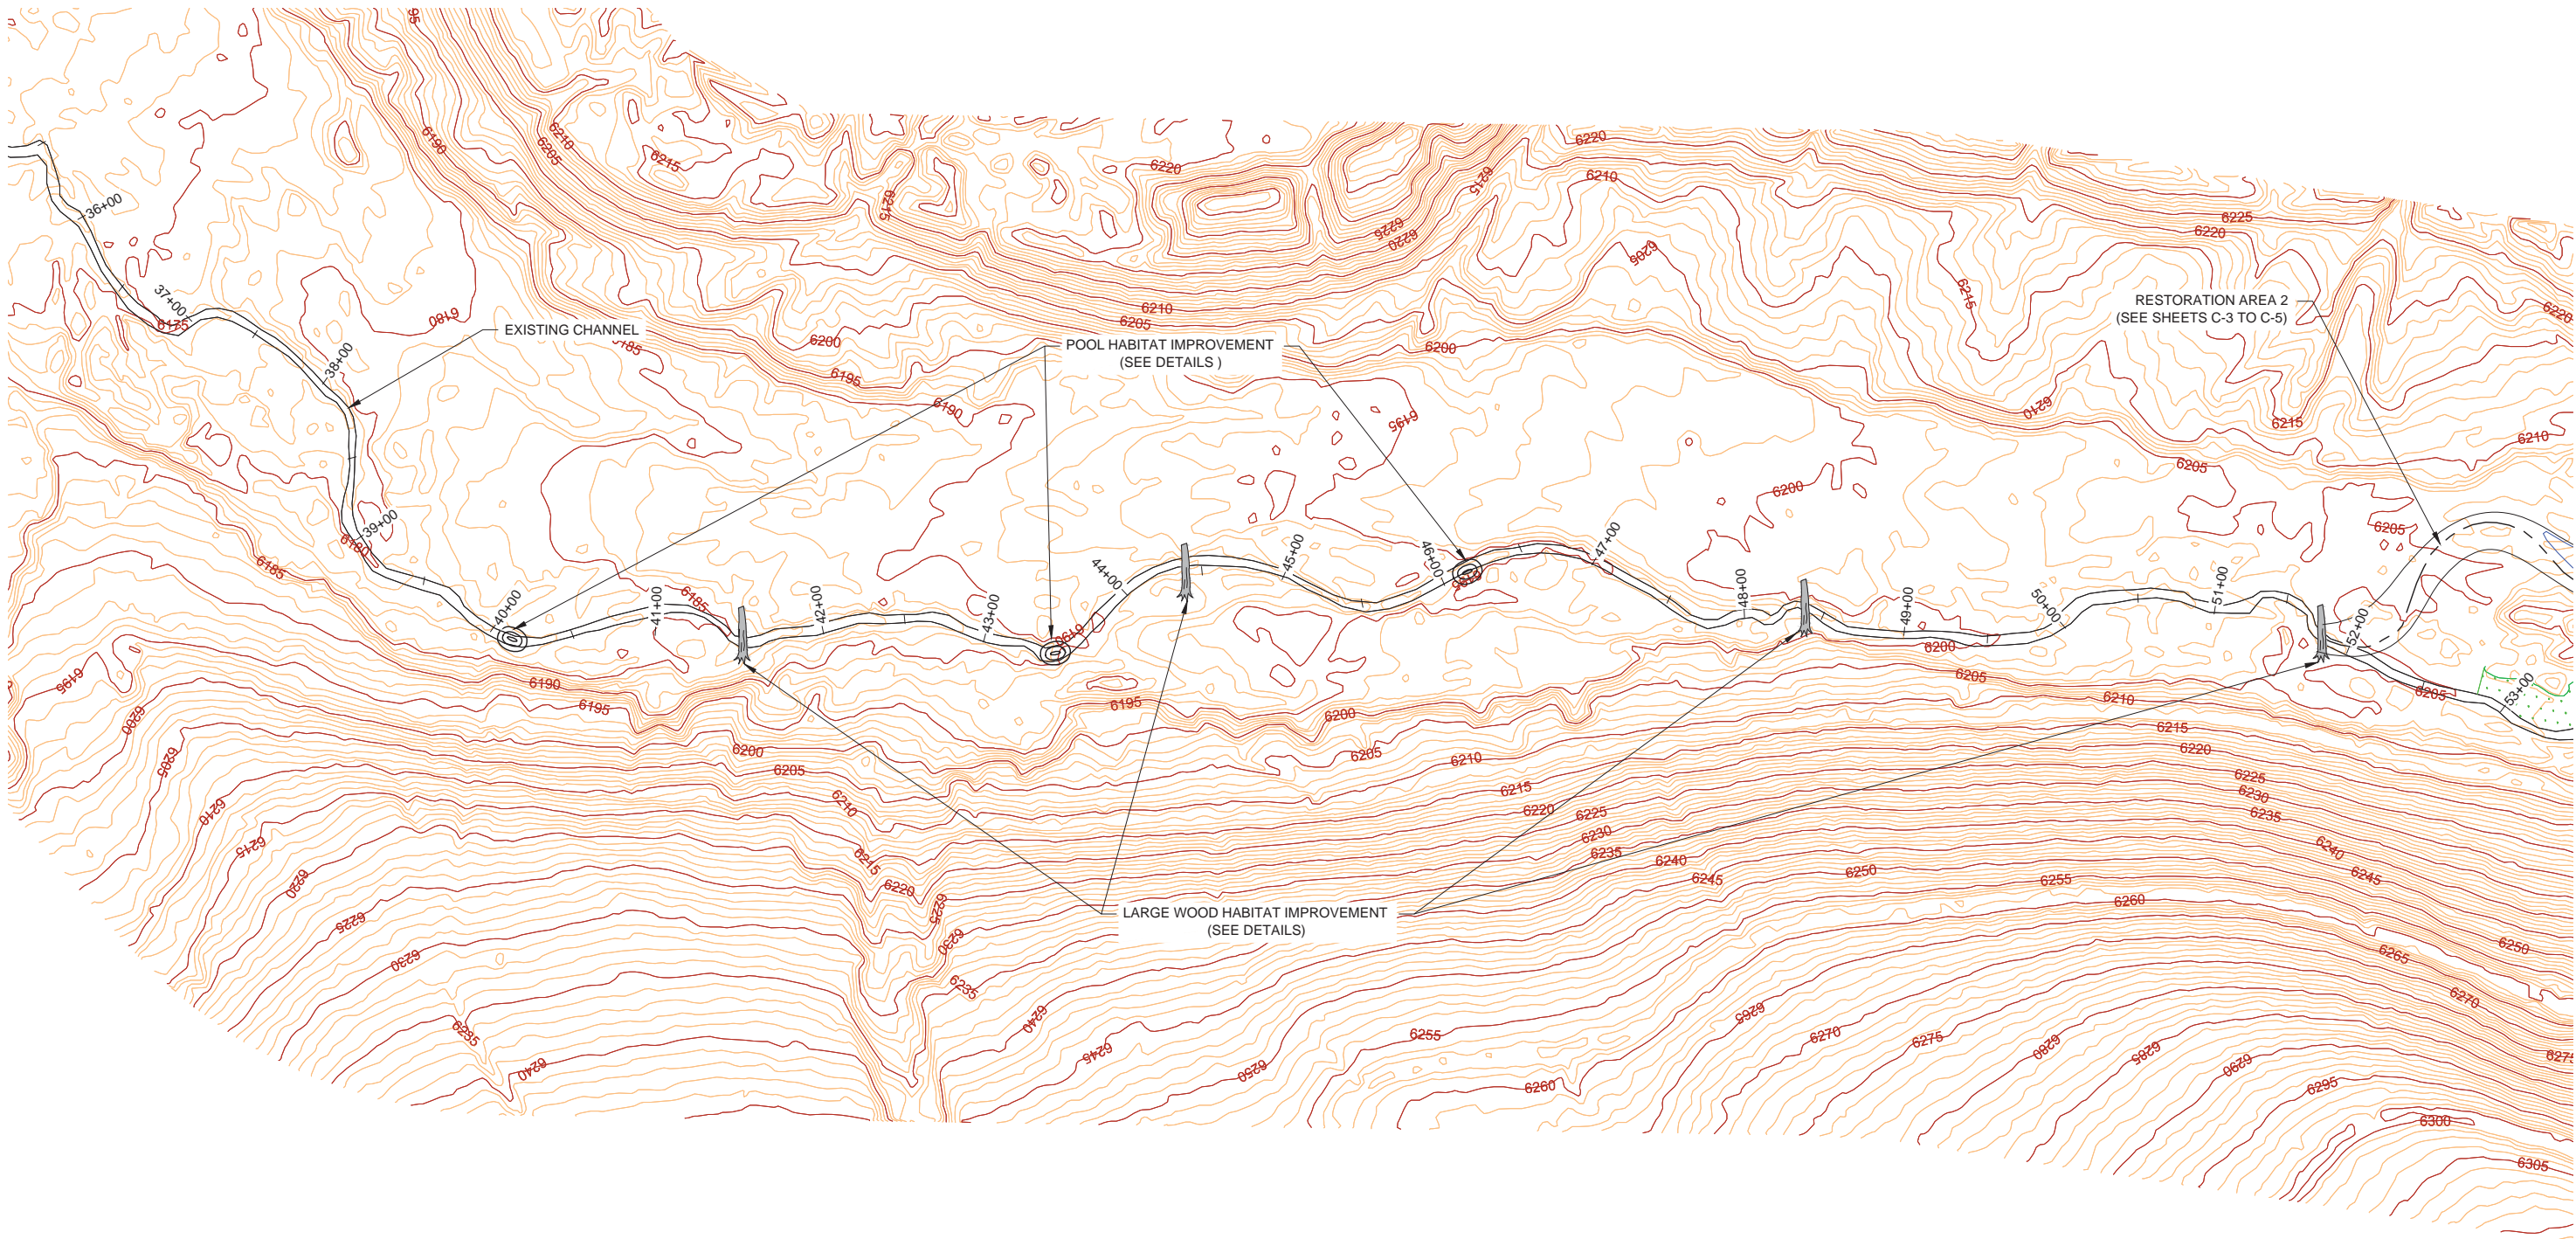
1. SURFACE CONTOURS CREATED FROM DIGITAL TERRAIN MODEL BY LIDAR METHODS FROM ROBERT PECCIA & ASSOCIATES, INC.
2. HORIZONTAL DATUM = NAD83 MONTANA STATE PLANE, VERTICAL DATUM = NAVD88
3. CONTOUR INTERVAL = 1 FT.
4. HABITAT IMPROVEMENT LOCATIONS SHOWN ARE APPROXIMATE. FINAL LOCATIONS SHALL BE APPROVED BY ENGINEER.
5. LARGE WOOD HABITAT IMPROVEMENTS SHALL BE EITHER EMBEDDED RIFFLE LOG OR BANK ROOT WAD AS DETERMINED BY ENGINEER.
6. ACCESS ROUTES AND EQUIPMENT FOR HABITAT IMPROVEMENTS SHALL BE SELECTED TO MINIMIZE DISTURBANCE TO EXISTING VEGETATION & SOILS.
7. USE ONSITE SALVAGE VEGETATION AND MATERIALS WHERE AVAILABLE AND APPROVED BY ENGINEER.
8. FOR POOL HABITAT IMPROVEMENTS, CONTRACTOR SHALL PRESERVE STREAM BANK STABILITY AND VEGETATION IF POSSIBLE. LIMIT ALTERATIONS TO POOL SECTION STREAMBED DIMENSIONS AS DIRECTED BY ENGINEER.

- WOOD HABITAT
- POOL HABITAT

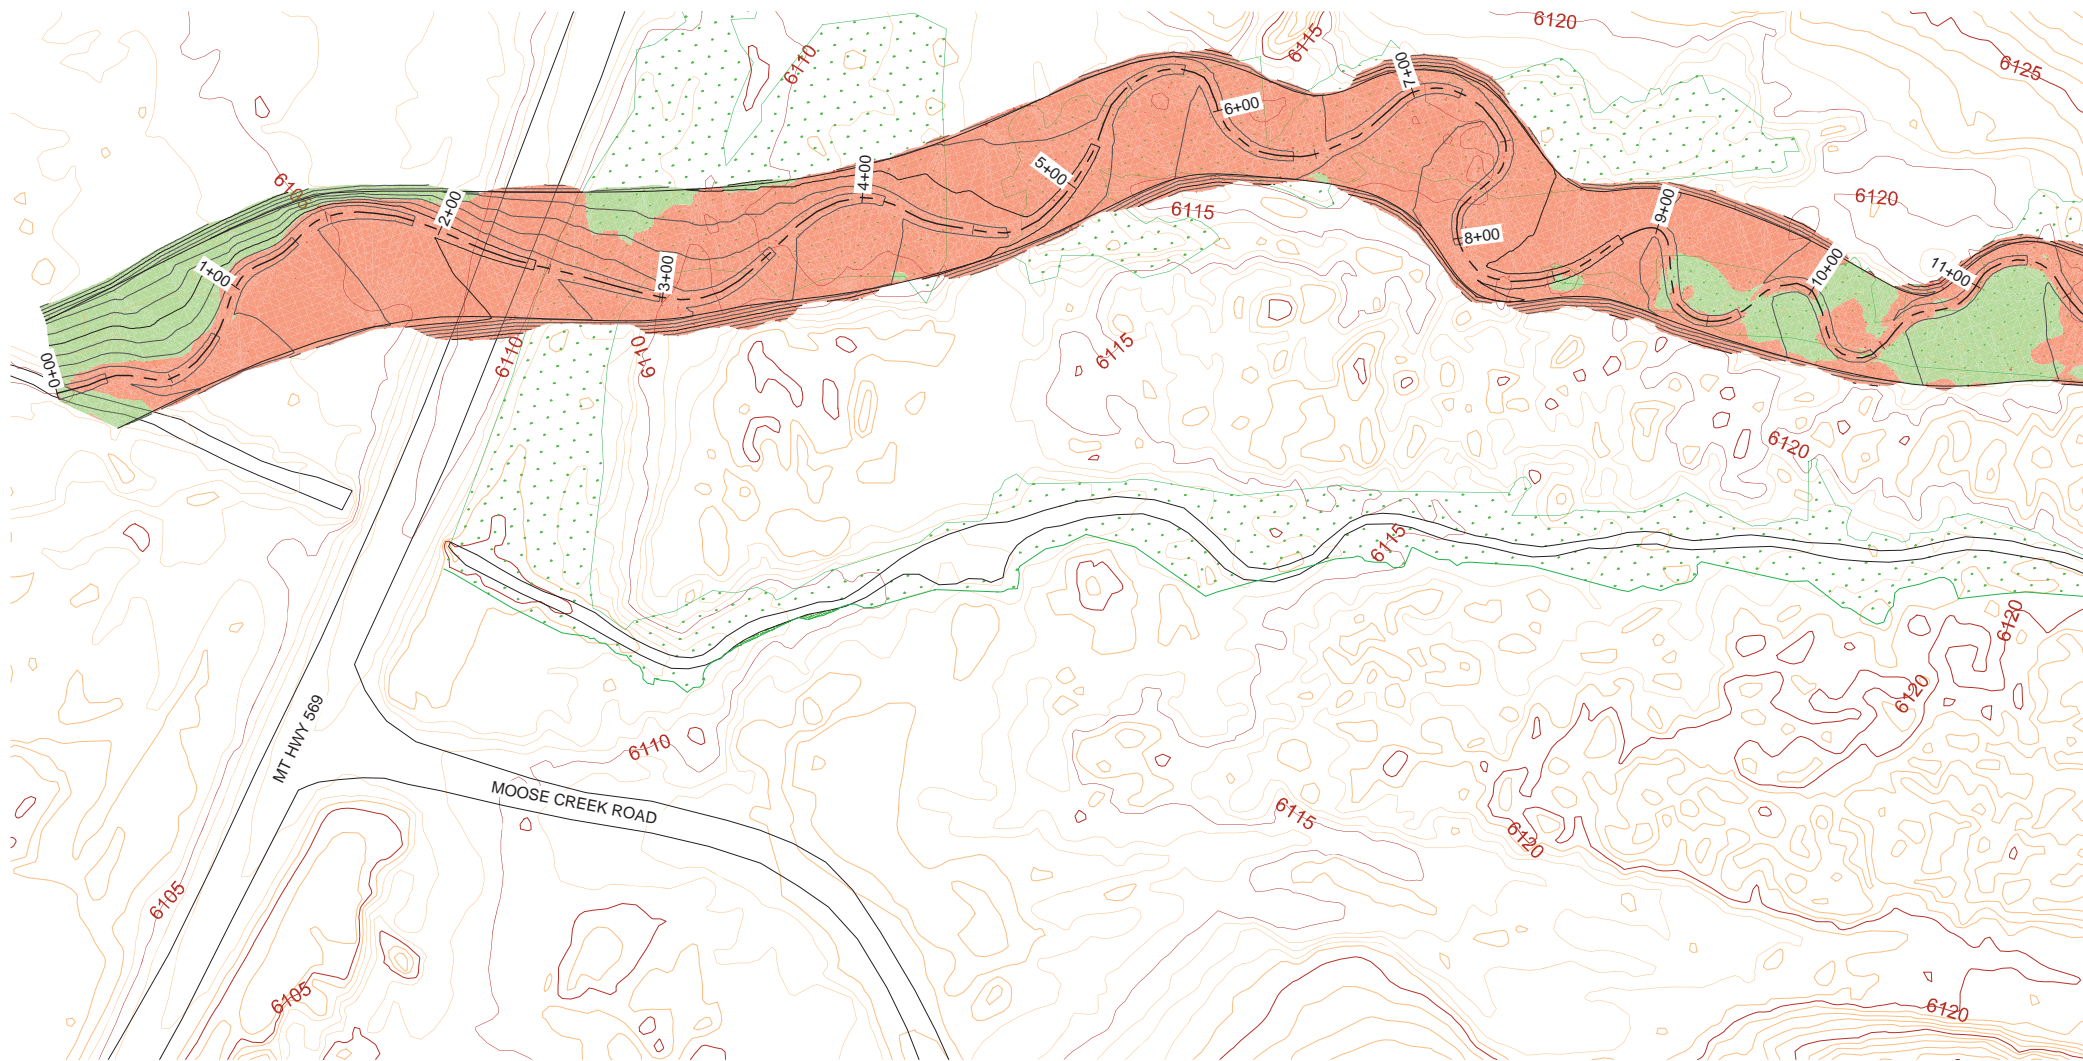
- NOTES:**
- 1. SURFACE CONTOURS CREATED FROM DIGITAL TERRAIN MODEL BY LIDAR METHODS FROM ROBERT PECCIA & ASSOCIATES, INC.
 - 2. HORIZONTAL DATUM = NAD83 MONTANA STATE PLANE, VERTICAL DATUM = NAVD88
 - 3. CONTOUR INTERVAL = 1 FT.
 - 4. SOLID RED HATCH DENOTES AREA OF CUT.
 - 5. SOLID GREEN HATCH DENOTES AREA OF FILL.
